SealBoss Case Study

Location: Santo Domingo Metro – Santo Domingo, Dominican Republic

Scope: Client is experiencing significant water intrusion through tunnel joints following application of positive side membrane. Expansion joint leaks must be proven completely dry in order to pass inspection. Said tunnel is for newly constructed metro rail system through downtown Santo Domingo, Dominican Republic

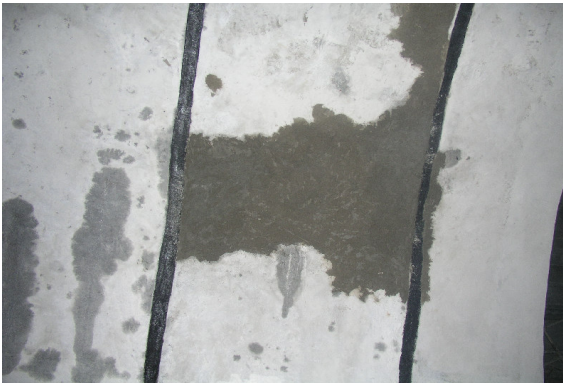
Figure 1. Active leaks at joint

Repair Method: Soluciones Ambientales del Caribe utilizes **SealBoss** 1570 water-activated hydrophobic polyurethane to seal joints in tunnel. Hundreds of gallons of 1570 are injected into the joints via 45 degree angle drilling behind the expansion joints. Injection ports are spaced 250mm apart utilizing 13mm x 60mm steel mechanical packers. Several kilometers of injection work is performed in order to pass dry inspection. Application leads up to Caribbean hurricane season during and after which dry inspection passes.

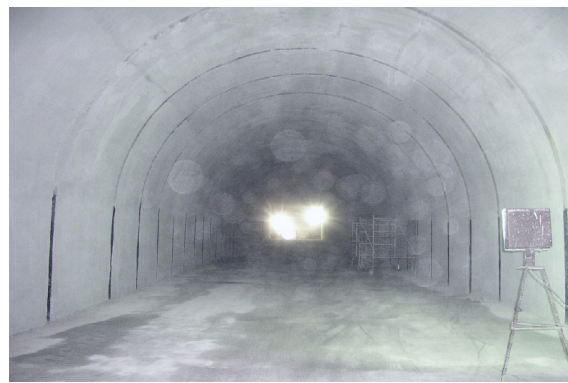
Figure 2. Tunnel Construction

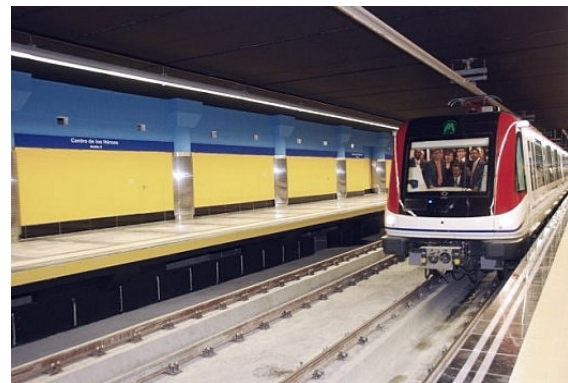
Figure 4. Dry terminal post inspection
