SealBoss ® Case Study

Client: City of Centralia Salzer Valley Wastewater Utility

Location: Centralia, WA

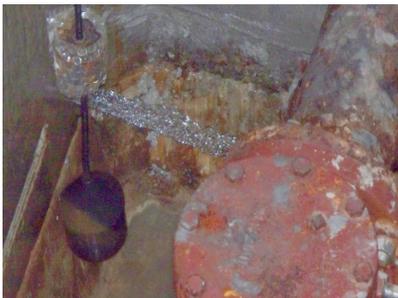
Scope: Client is experiencing water infiltration through Valve Vault. The estimated water intrusion is 15GPM. Possible water intrusion problems arise from high water table producing significant hydrostatic pressure requiring high pressure application of chemical grouts capable of combating ground water pressures.

Figure 1. Vault Water Infiltration

Repair Method: SealBoss Corp. recommends a high pressure polyurethane resin injection on the two sides of the vault allowing water infiltration. Hydroactive polyurethane grout, SealBoss 1510 is then injected into these areas creating a closed-cell, flexible seal against groundwater infiltration while eliminating hydrostatic pressure inside the vault walls. The result, as pictured below, is a fully-sealed, dry valve vault. Infiltration was decreased from 15GPM to leak-free.

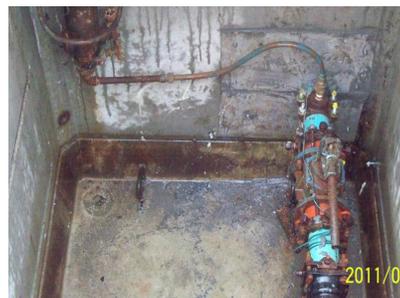
Figure 2. Dry Vault
