## SealBoss ® Case Study

**Location:** Walnut Creek, CA

**Scope:** Client is experiencing significant water intrusion through elevator pit cold joints. The below grade nature of the construction has allowed for significant hydrostatic pressure to enter through the wall/slab cold joint as seen in the pictures below. These joints require a chemical injection method for polyurethane resin which will seal the entire joint around the perimeter of the elevator pit.

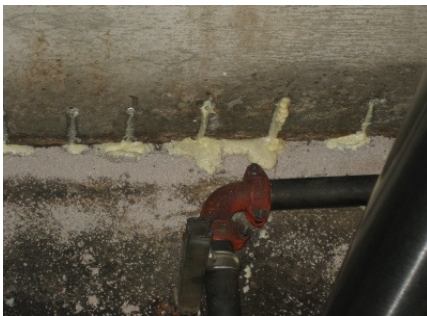
*Figure 1. Drill hole placement*

**Repair Method:** SealBoss Corp. recommends a high pressure polyurethane resin injection around the entire perimeter in order to seal the wall/slab cold joint which is the culprit for water intrusion. By drilling at a 45 degree angle from the wall to the joint, the applicator intersects the joint half way through the thickness of the substrate. After setting mechanical injection ports, the joints were then injected with SealBoss ® 1510 hydrophobic polyurethane injection resin. As seen below, the polyurethane foam contacts moisture in the joint, creating an exothermic expanding reaction which creates a flexible, permanent, fully penetrated seal within the joint.

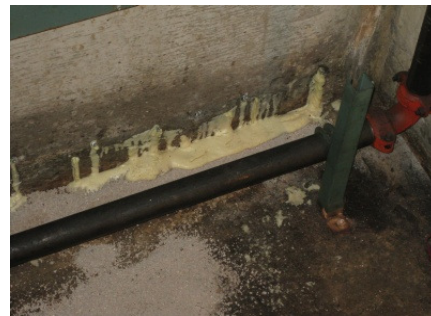
*Figure 2. Expanding 1510*

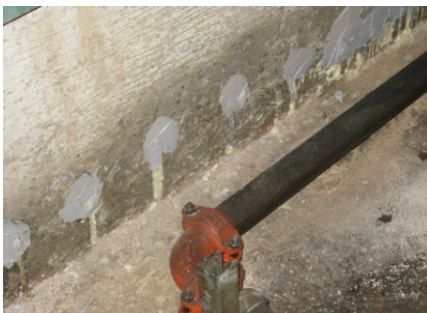
*Figure 3. Post Injection Patch*

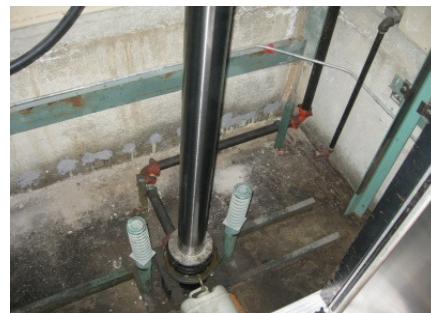
*Figure 4. Dry Elevator Pit*
