SealBoss® Case Study

Location: Christchurch Casino – Christchurch, New Zealand

Contractor: Canterbury Waterproofing Limited

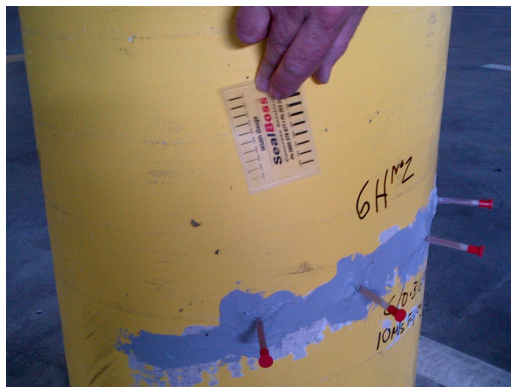
Figure 1. Measuring Crack Width

Repair Method: Equus Southern submitted SealBoss® 4000LV and SealBoss® 4000 QuickSeal for the structural injection of these cracks. Through a process of low pressure chemical injection, Canterbury Waterproofing Limited successfully injected hundreds of structural cracks and structures throughout the casino. Through strict Quality Control guidelines of material volume documentation, the team was able to present quantitative injection results to engineers.

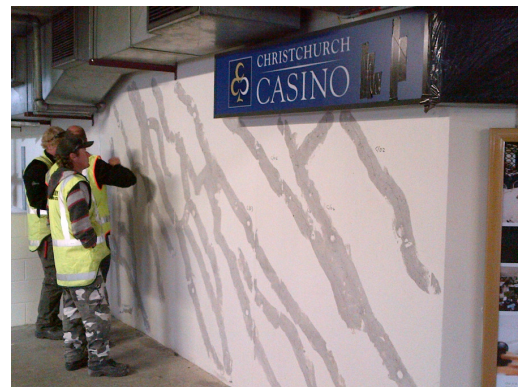
Figure 3. Wall crack prep work

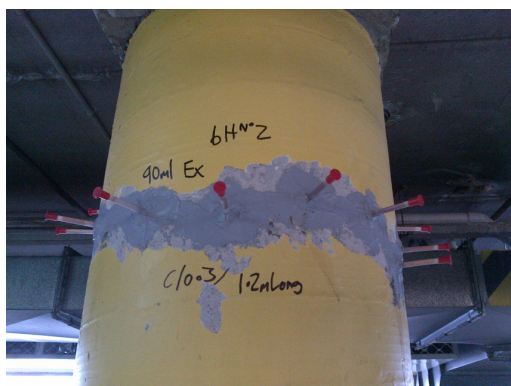
Figure 3. Quality Assurance Practices

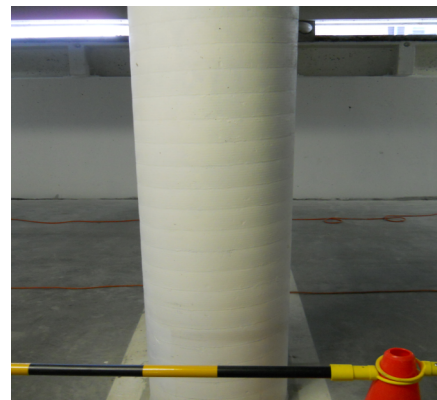
Figure 4. Completed Beam
